# Paralleling CAPACITORS

Differences in maximum ripple current and ESR can lead to a shift in the ripple current – and premature failure. by MARK WOOLLEY and JAE CHOI

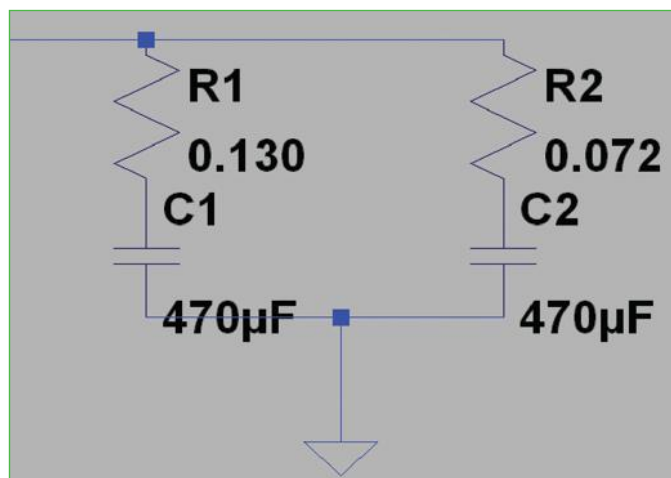
The ESR of a capacitor acts as a resistance in series with the capacitance (**FIGURE 1**). The difference in ESR meant that the ripple current did not split evenly between the two capacitors. Equation 1 shows the calculation of current through the resistors (and hence the capacitors).

**FIGURE 1.** A simplified schematic of the circuit.

Given the values shown above and the estimated total ripple current of 1400mA,  $I_{R1}$  is ~500mA (640mA max), while  $I_{R2}$  is ~900mA (760mA Max). The ripple current through  $C2$  is about 20% greater than allowed. This excessive ripple current caused  $C2$  to overheat and lose its electrolyte.  $C2$  then acted as an open circuit, forcing all ripple current through  $C1$ , quickly causing its failure as well.

The standard practice of using parallel capacitors to increase the ripple current capacity and reduce the total output resistance must be used with caution. The capacitors must be identical in ESR and ripple current, as well as in capacitance. Otherwise, the ripple current will not be split evenly and will cause early life failures. **PCD&F**
